Manhole Inspection Summary

Manhole # S04II2003MH

Insp Date: **7/19/06 8:33 AM**

Location Address: **3209 SHELLBURNE RD**

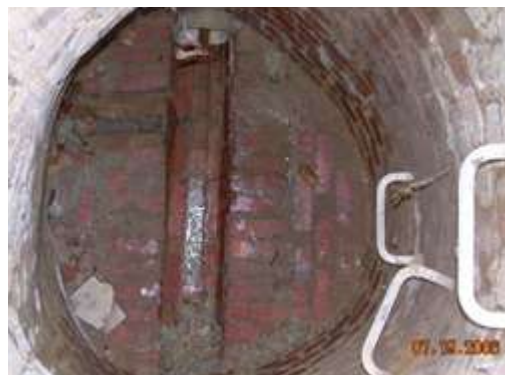
Top View

Corbel and Barrel infiltration. Bench debris. Channel debris.

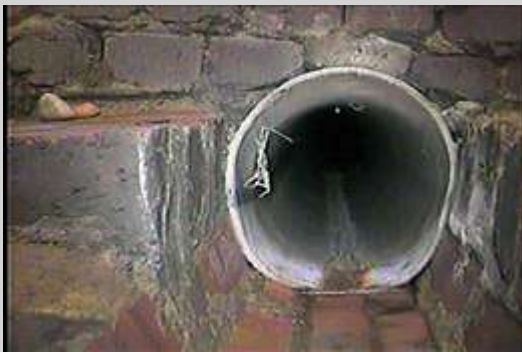
8 in. Circular Gravity Sewer Pipe Out @ 12 O'Clock

Barrel deterioration and infiltration.

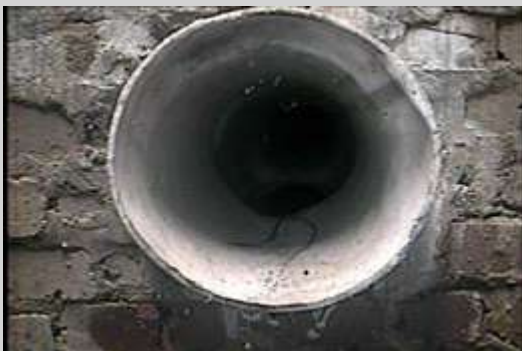
8 in. Circular Gravity Sewer Pipe In @ 6 O'Clock

Deposits: ☐ None ☐ Mud ☐ Sludge ☒ **Debris** ☐ Grease

Silt Depth: **4** (in.) Deposits Extent: **Heavy**

Infiltration: **Evidence** Pipe Seal Cond: **Cracked**

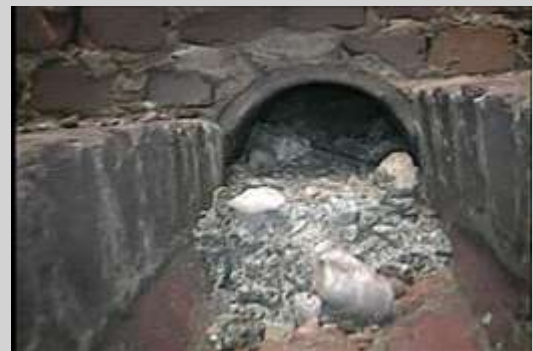
Drop In @ 6 O'Clock

Drop: **Outside** Rod and Bar
Angled: **Yes** Reading: **5.10** (ft.)
Inv Depth: **6.10** (ft.)

Drop Condition: **Partly Clogged**
